The Konfort VAS 581 003 does not perform the recycling phase correctly

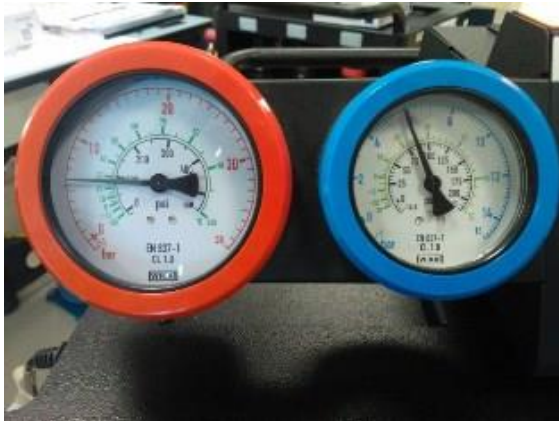
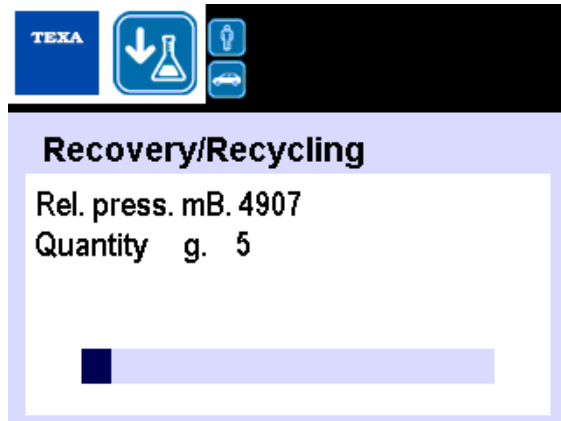
During the recycling phase, the pressure on the gauges and on the display of the **Konfort VAS 581 003** does not decrease or decreases very slowly:

- Make sure that the **quick couplers** will be properly connected and screwed into the corresponding fittings on the A/C system of the vehicle.
- Select, from the **Additional Functions** menu, the option named **Non-Condensable Gas**:
