The message "Purge Failed" or "Autozero Failed" is displayed

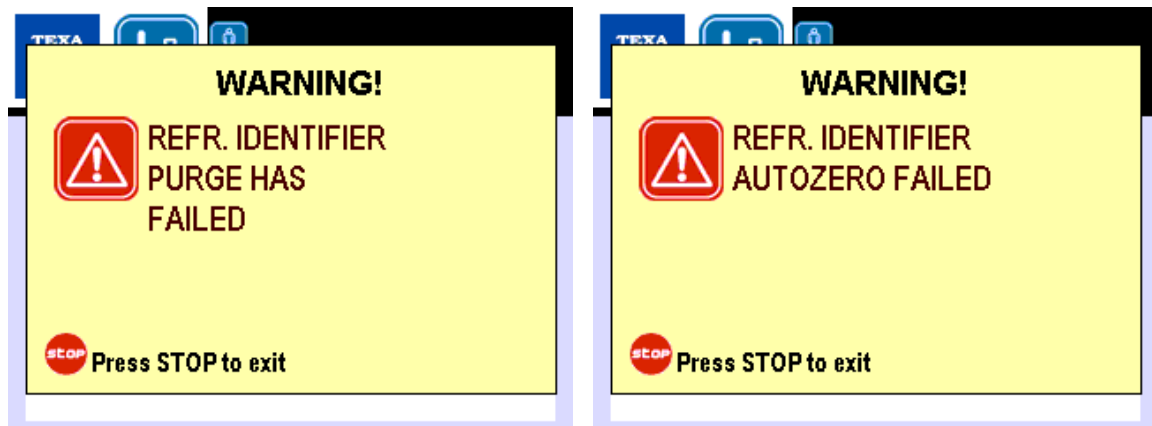
Before starting the refrigerant recycling phase, the **Konfort VAS 581 003** displays one of the following messages:
