The Konfort VAS 581 003 displays the message "Contaminated Refrigerant"

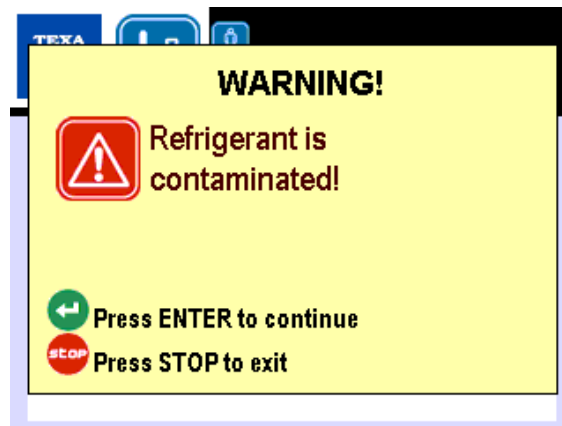
Before starting the refrigerant recycling phase, the **Konfort VAS 581 003** displays the following message:

- Press the **ENTER** button to confirm the message and follow the instructions. The unit will allow to perform maximum two more measures of the refrigerant purity before stopping the service.
- Start the procedure for the **Identifier Check** by confirming the request which will appear by pressing the **STOP** button to the message "Contaminated Refrigerant" (see above) or by selecting the specific function named **Refrigerant Identifier Check** available from the **Additional Functions** menu:
