During the oil/UV injection the message "Oil Injection Error" appears

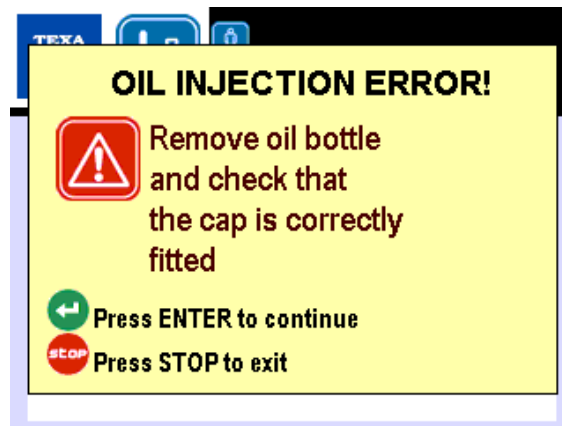
During the oil or UV additive injection phase, the Konfort VAS 581 003 displays the following message:
